North Coast Regional Water Quality Control Board

Inspection Report

Site: Black Oak Ranch, Mendocino County APNs 013-570-48-00, 013-560-47-00, 013-560-46-00
CIWQS Place ID: 858854
Inspection Date: June 3, 2019

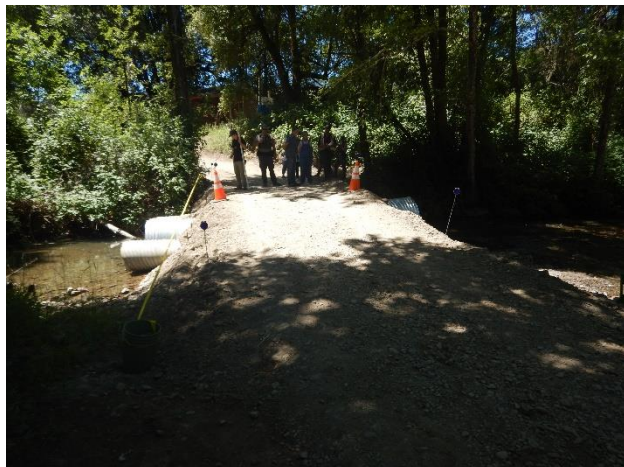
Photo 1 –C1

Staff observed and measured the dimensions of the recently-constructed stream crossing. The crossing was 43 feet long by an average of 14.9 feet wide (5 measurements of 14.5', 14', 15', 14' and 17', respectively), and an average of 4.1 feet deep. The fillslope was at a vertical grade throughout the prism. The approximate surface area associated with C1 is 641 ft². The CMPs were completely contained within the vertical fill and the inlets and outlets extended out past the upstream and downstream fillslopes. Based on these measurements, Mr. Barsotti placed approximately 2,287.5 ft³ of fill material within the main channel of a class I watercourse. Immediately upstream of the crossing, I observed a pool in the channel with several juvenile salmonids (photo 4). The crossing itself is not properly compacted, and at several locations, while measuring the dimensions of the fill prism, my foot sank into the fill, pushing fill into the creek below.

2. Retain a qualified professional to develop a workplan and schedule to remove the fill material associated with C1 and restore the channel to its natural state. Dispose of all development and restoration-related earthen spoils in a manner to prevent/minimize transport and delivery to receiving waters.

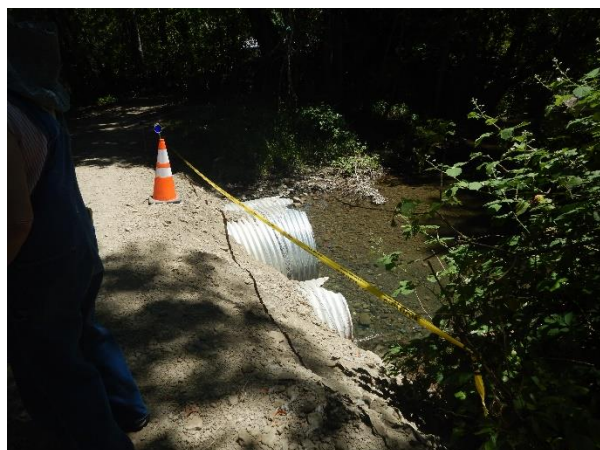
Photo 3 – C1 Inlet	Photo 4 – Salmonids in pool above C1

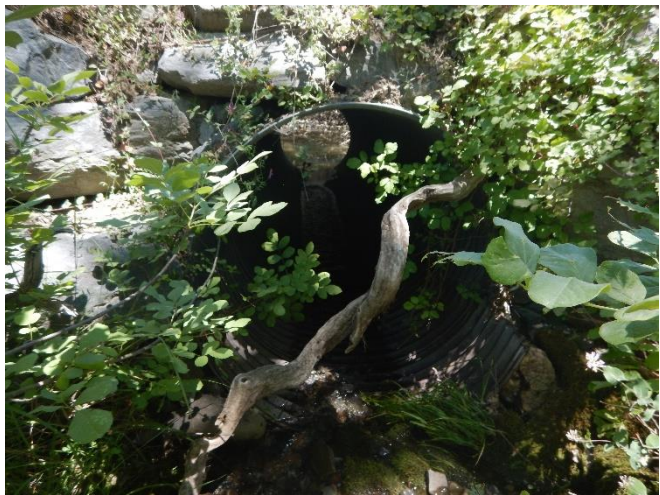
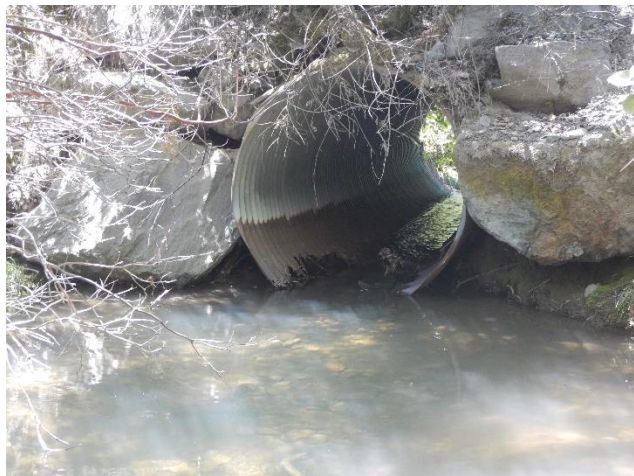
After observing and documenting conditions at C1, we walked to inspection point C2, a culverted watercourse crossing in the southwest portion of the Property. The culvert at C2 is a 48" CMP situated within a stable fill prism. The culvert is slightly perched and the bottom of the pipe is rusted through at the outlet (Photos 5-6)

Photo 5 – C2 Inlet	Photo 6 – C2 outlet. Rusted out culvert bottom visible

1. Retain a qualified, licensed professional to inventory, assess, and develop a workplan and schedule to implement measures to ensure that all developed features, roads, watercourse crossings, instream features including the instream impoundment, are corrected, restored, and/or maintained in conditions that prevent or minimize erosion, sediment transport/ delivery, and adverse impacts to water quality and beneficial uses. Include measures to ensure that unstable features caused or affected by onsite development and operations are removed or otherwise protected so as to minimize the potential for these features to cause adverse impacts to water quality and beneficial uses. Dispose of all development and restoration-related earthen spoils in a manner to prevent/minimize transport and delivery to receiving waters.

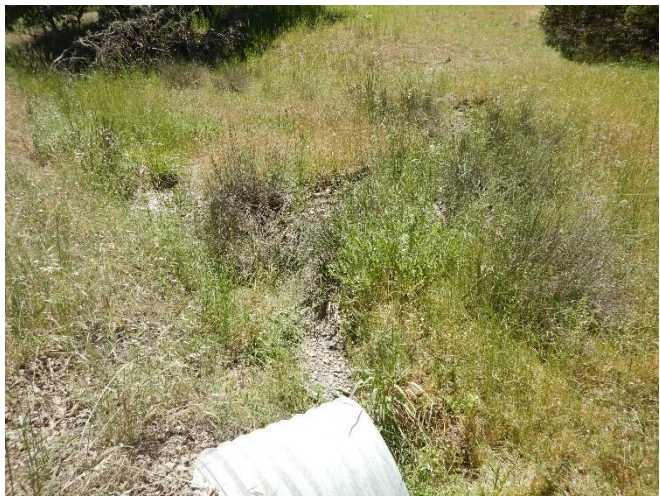
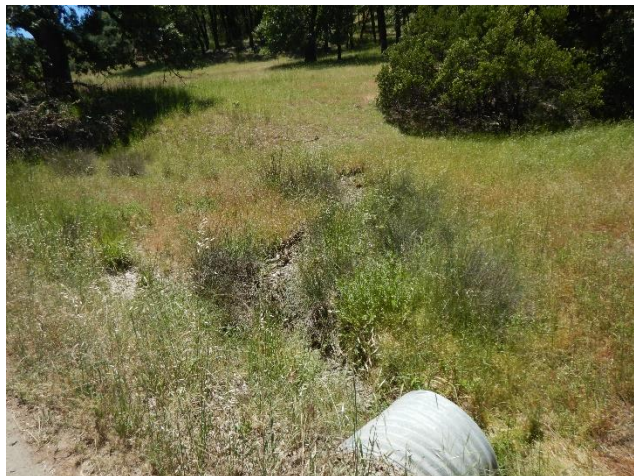
Approximately 500 yards north of C2, I observed a culverted watercourse crossing identified as inspection point C3. The culvert at C3 is a 30" CMP, with a misaligned inlet and a perched outlet, approximately 1 foot above the stream channel (Photos 7-9).

Photo 7 – C3 inlet, misaligned with the channel	Photo 8 – Second view of C3 inlet

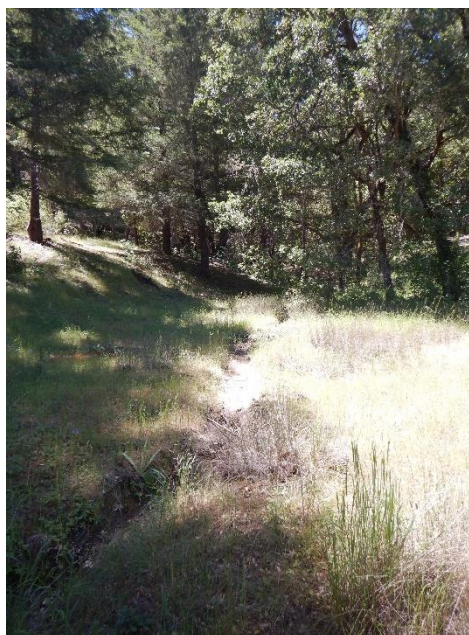
Continuing north along the access road, we observed a class III watercourse that had been diverted into the inboard ditch of the road, which is unrelieved for several hundred feet, and discharges to a class II watercourse at a culverted crossing (C5) (Photos 10-12). I observed evidence of erosion and sediment transport in the inboard ditch. Downstream of the road at the point where it intercepts the Class III watercourse (C4), I observed an agricultural field (not photographed) that appears to drain towards a low-lying area with two grazing cows. In the low-lying area, I observed wetland indicator vegetation, including facultative species littleseed canary grass, juncus, rumex, and Todd Rush. I also observed Brome species in this area.

Photo 10 – Channel uphill of C4

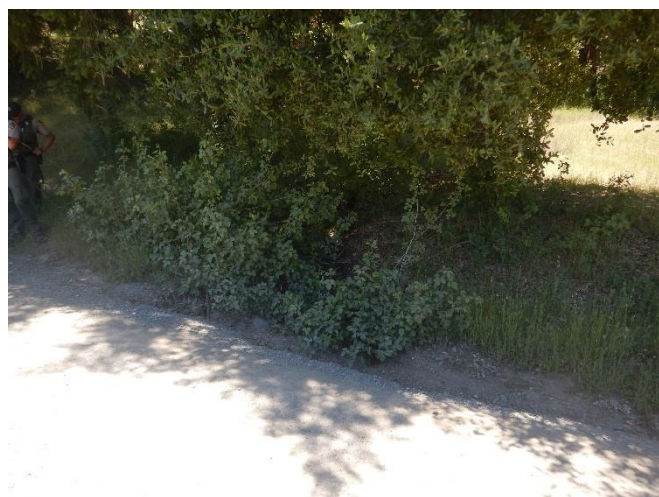
Photo 11 – C4 where the road intersects a class III channel, rerouting it to the inboard ditch

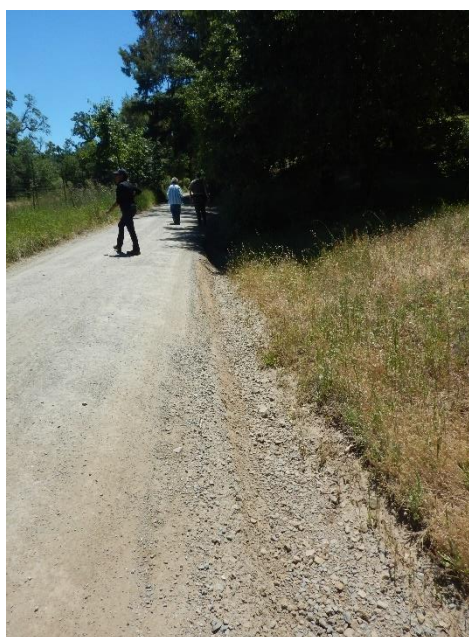
Photo 12 – Inboard road ditch that conveys flows from a Class III watercourse to a Class II watercourse north of C4.

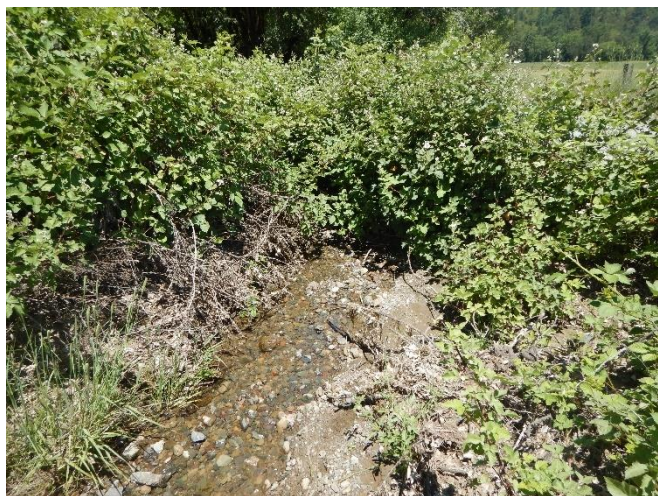
The culverted crossing at inspection point C5 appears to be stable, but we observed that the outlet is perched. See photos 13 and 14.

Photo 13 – C5 Inlet, hidden in blackberry thicket

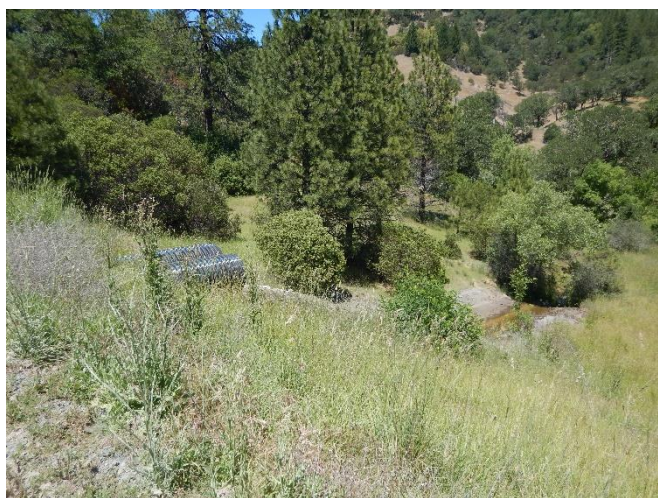
Photo 15 – Outfall of P1

Northwest of crossing C5, along a spur road off the main access road, I observed an impoundment, identified as P1 on Figure 1 (photos 15-16). The spillway of the impoundment consists of two, 30" corrugated plastic pipes (CPP), that drain onto a concrete spillway that extends for at least 100 feet to a channel below. The fill slope and berm of the impoundment appear stable and adjacent residencies use the road on top of the berm as an access road. The culverts are perched above the concrete spillway.

<i>Inspection Point</i>	<i>Brief Description</i>	<i>Water Quality Concern</i>	<i>Associated Photo(s)</i>
P1	Onstream pond with perched, possibly undersized outfall	Potential for overtopping and uncontrolled discharge; potential for erosion and sediment delivery to receiving waters.	15-16

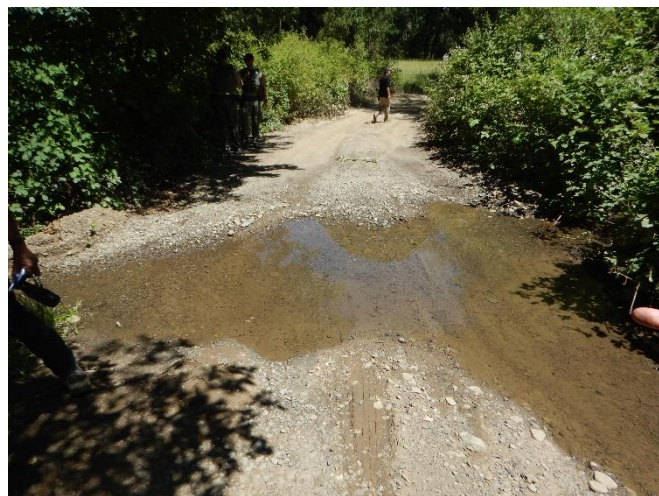
Photo 17 – C6 ford crossing

After observing P1, we walked east along another spur road, where I observed a ford crossing on a class II watercourse, labeled C6 on Figure 1 (photos 17-18) The ford was gently sloped, but did not appear to be adequately armored to protect the channel from traffic-related damage/disturbance.

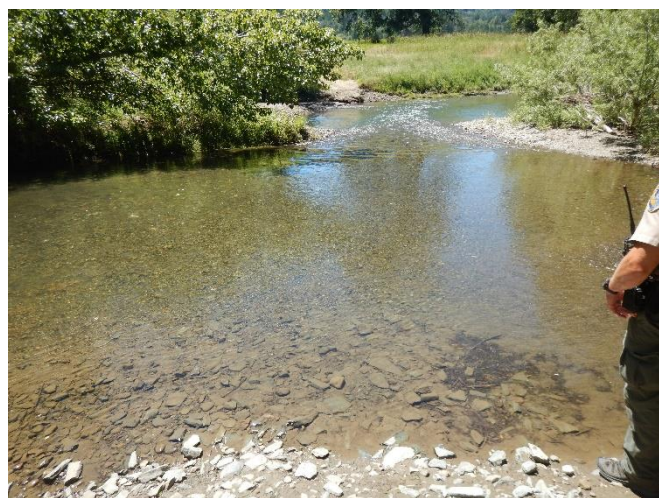
Photo 19 – C7 ford crossing along 10-Mile Creek

After observing the crossing at C6, we walked back to the vehicles and travelled back along the main access road to highway 101. We travelled southeast along the highway for ¼ mile to another access road that led us to APN 013-570-48-00, where we parked and walked to a ford crossing on mainstem 10-Mile Creek (C7 on Figure 1, photo 19). Mr. Barsotti stated that he only uses this crossing during periods when there are no stream flows at this location, and the channel is dry at the crossing. I observed no water quality issues with this site. However, Mr. Barsotti also stated that he did not obtain any permit to use the ford for vehicle traffic purposes.

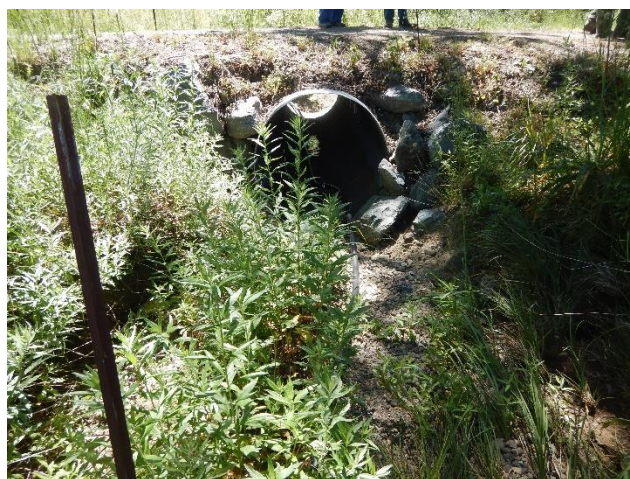
Photo 20 – C8 inlet

Up the road from C7, along a tributary to 10-Mile Creek, I observed a culverted watercourse crossing, C8. The culvert at C8 consists of a 48" CMP (photos 20-21) that is horizontally and vertically misaligned with the channel.

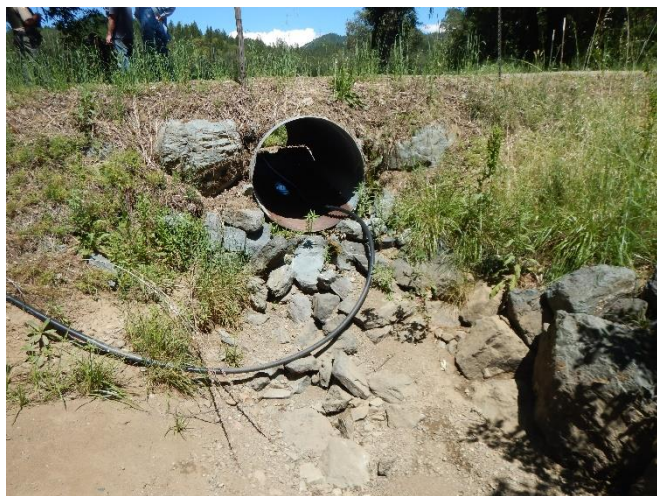
Photo 21 – C8 outlet. Not visible in this photo: the creek turns drastically to the left just outside of the frame.

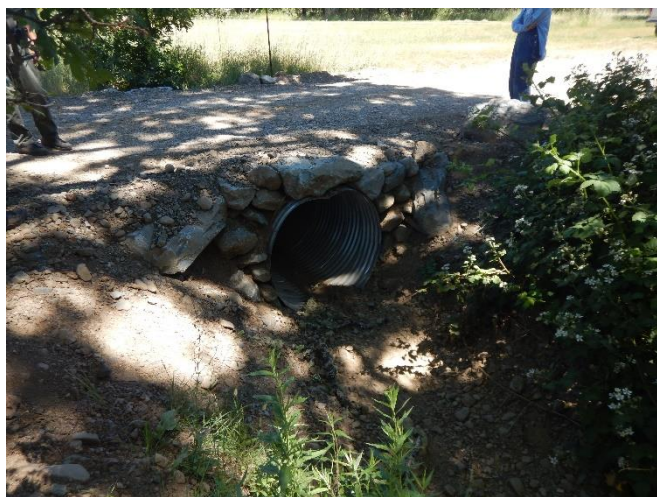
Photo 23 – C9 Outlet

Farther east along the access road, I observed a culverted watercourse crossing, C9, consisting of a 48" CMP that appeared stable and fairly well-aligned with the stream

channel (photo 23). Mr. Barsotti stated that he replaced the culvert last year, matching culvert size to a Caltrans culvert just upstream at Highway 101. Mr. Barsotti stated that he did not obtain a permit to conduct the work instream and was not aware that he needed a permit. I observed a pile of earthen spoils adjacent to the crossing and perched next to the watercourse (photo 25). I also observed fine sediment deposits in the culvert and at the base of the outlet (photo 24), suggesting that fill from the crossing installation likely discharged into receiving waters.

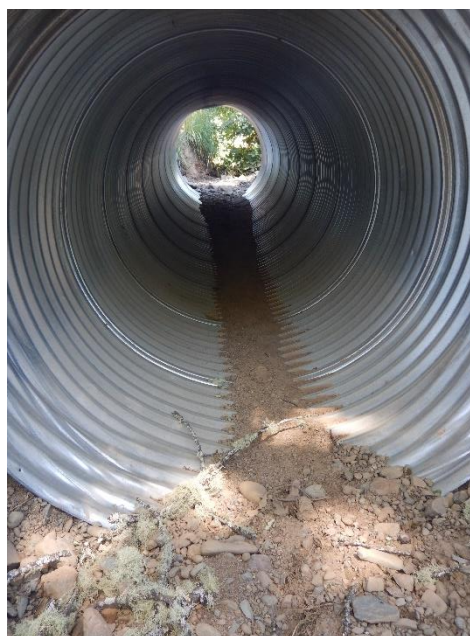
Photo 24 – C9 fine sediment deposits associated with the recent installation of C9

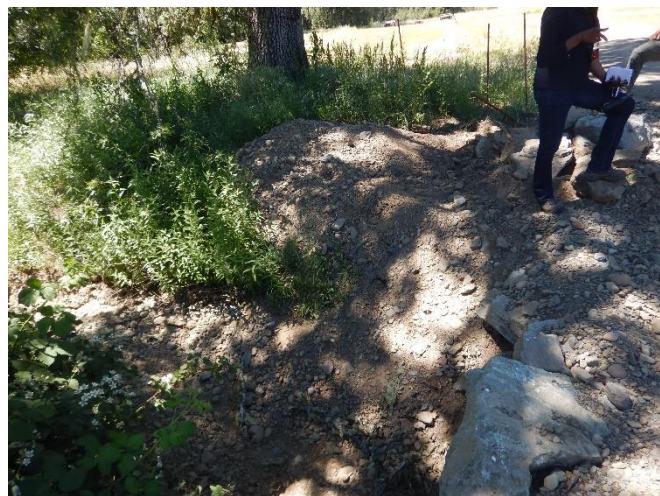
<i>Inspection Point</i>	<i>Brief Description</i>	<i>Water Quality Concern</i>	<i>Associated Photo(s)</i>
C1, C2, C3, C4, C5, C6, C7, C8, C9, C10, C11, C12	Stream Crossings	Stream crossings not properly installed/ sized/maintained. Potential for erosion and sedimentation in a watercourse channel.	1-14, 17-34
C1	Fill in Watercourse	Fill placed, without authorization, in waters of the state.	1-4
C9	Earthen spoils piled adjacent to watercourse	Waste earthen material placed where it can enter receiving waters.	25

Photo 25 – Spoils from C9 installation adjacent to watercourse and crossing

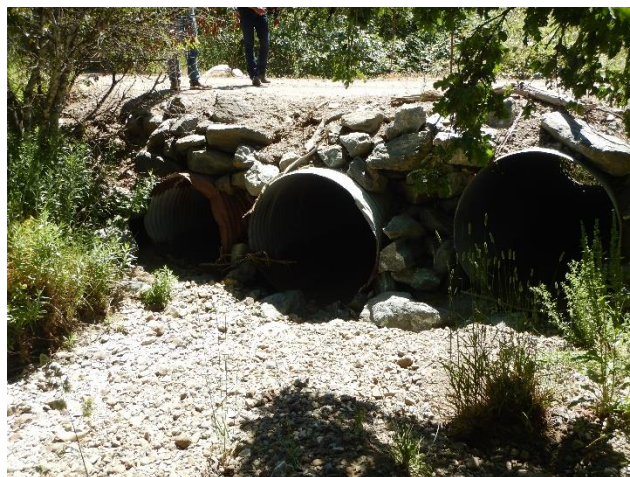
Approximately 200 yards east of C9, I observed another culverted watercourse crossing, labeled C10 on figure 1. The crossing at C10 consists of three CMPs, with 24", 48" and 36" diameters, respectively (photos 26-27). The fill along the crossing appeared stable, and the culverts were fairly well-aligned with the watercourse channel. However, the overall width of the channel suggests that the crossing is unlikely to adequately pass debris, and potential flow, associated with winter storms.

Photo 26 – C10 inlet, three culverts visible within the crossing prism.

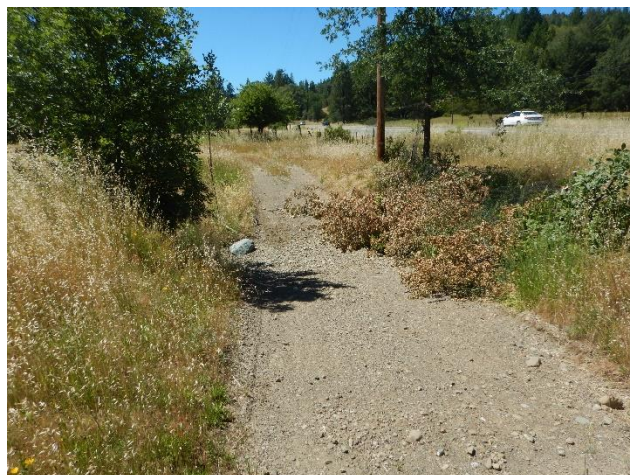
Photo 28 – C11

Upstream from crossings C9 and C10, I observed two rocked fords, identified as inspection points C11 and C12, respectively. The road approaching C11 is a shallow grade, but the ford itself lacks adequate armoring to protect the channel from traffic-related damage/disturbance (photos 28-30). The road approaching C12 is steeper, and I observed erosion on the southern side of the crossing. This ford also did not appear to be adequately armored (photos 31-32).
